**Flood Control Project Maintenance
Levee Inspections**

Fall 2018 Levee Maintenance Deficiency Summary Report

Reclamation District No. 0150 Merrit Island

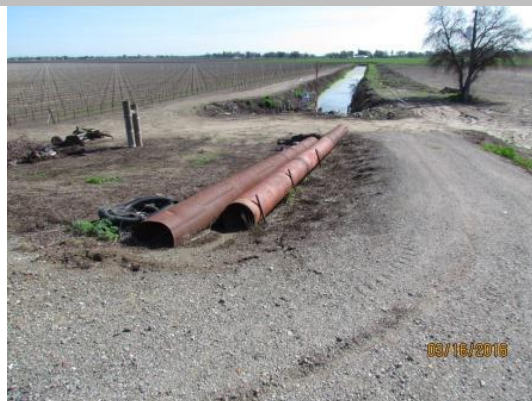
Photo 1 of 1 : FA_2018_RD0150_17_95_20180910_00092.jpg

LM Start	5.05	Rating **	M	Issue No.	95
LM End	5.05	Issue Type +	En	Location *	LS
Category	Earthen Levee			GPS Latitude/Longitude	
				Start	End
Item	Encroachments			38.379617 °	38.379617 °
				-121.540058 °	-121.540058 °
DWR ID	DWR_RD0150_03_s_2016_95				
Comment Code					
PI : Pipe					
Inspector Comment					
Abandoned pipe was found on the landside slope of the levee.

View of an abandoned pipe on the landside slope of the levee. Spring 2016

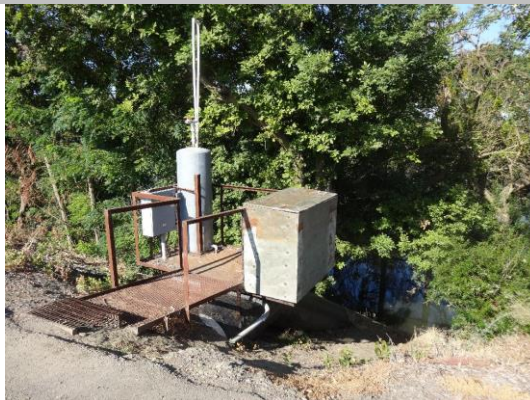
Photo 1 of 3 : UCIP_FA_2018_49386_63902.jpg

FS_ID:49386
DS_ID:22446
EP_NO: N/A
Repair Type: No Action Needed
Crossing Status: Found
UCIP Comments: 5/2014 Recordation from permit files 13736 match photos and approximate location of UCIP confirmed crossing. 8/2013- a smaller pump on WS steel deck and was running.- seems 30-inch steel pipe goes through the levee.- GI electric conduit on WS and power pole on LS.
FIELD_STRUCT_DESC: 24-inch steel drainage discharge pipe through the levee, 10.5 feet below the crown. Flap gate on the waterside (WS) end. Pump and gate valve at the landside (LS) toe. (Plans to install a 24-inch discharge pipeline through the levee authorized under Permit No. 13736, 1983 - Reclamation District No. 150 [RD0150]). [Additional Reference(s): DWR Levee Log, 2005. USACE Sacramento O&M Manual 112, March 1957, (HLM 5.15), 30-inch pipe referenced, invert elevation 14.5 feet below the crown].
FS Date: 8/23/2013

WS view: pipe, steel deck, pressure tank, electric control box on stream bank.

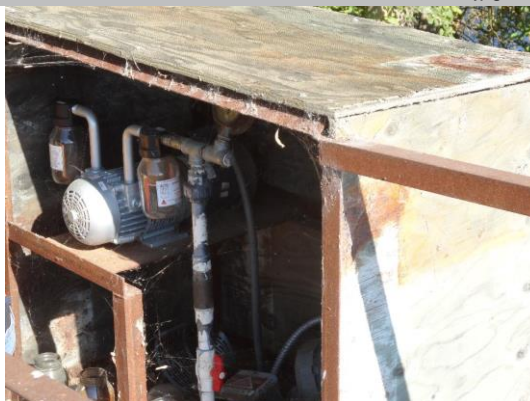
Photo 2 of 3 : UCIP_FA_2018_49386_63901.jpg

WS view: a smaller pump on steel deck. It was working during the survey.

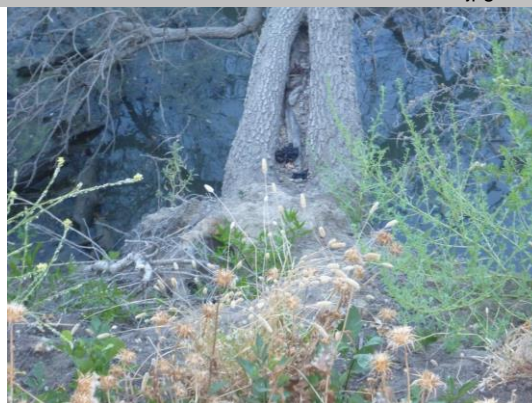
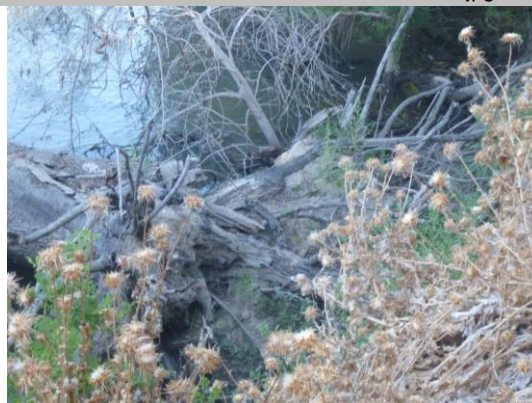
Item	2017 Storm Damage			38.380906 °	38.380928 °	
				-121.540344 °	-121.540364 °	
DWR ID	DWR_RD0150_03_f_2017_111					
Comment Code						
Inspector Comment						
Levee Evaluation Comments						
Description:On 19 January 2017, two large trees were observed to have fallen into the water exposing the root ball on the waterside levee slope on the east (left) bank of Elk Slough. The site is approximately 10 feet long. See attached pages for photos.						
Site ID No:309						
Site Designation:LMA-135						
Repair Type: Erosion						
Rating:Area of Concern						
Field Date:7/18/2017						
Notes: 2 oak trees fell over at the WS toe and took root balls out of the lower slope about 5 ft deep just above the water line. Area of concern because damage is only on the lower slope near the water line.

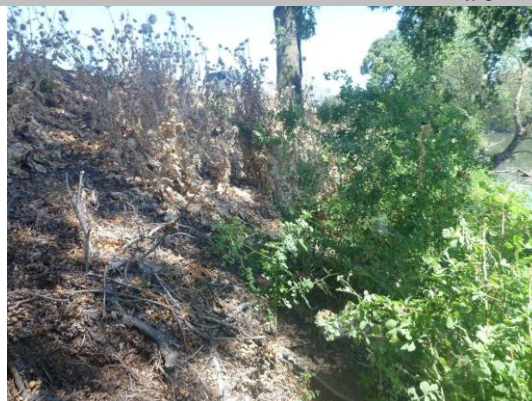
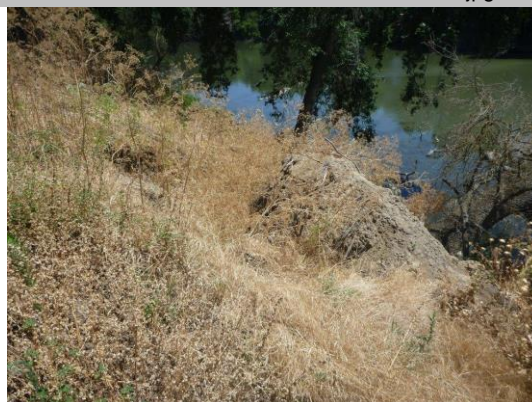
Comment Code					
Inspector Comment					
Levee Evaluation Comments					
Description:Cracking and erosion were observed on the waterside levee slope on the east (left) bank of Elk Slough. The site is approximately 40 feet long. See attached pages for photos.					
Site ID No:310					
Site Designation:LMA-136					
Repair Type: Erosion					
Rating:Serious					
Field Date:7/17/2017					
Notes: Large oak tree fell over here and took a root ball with it. At least 15 ft wide by 5ft deep soil missing, 5 ft from crown. Longitudinal cracks for 40 ft along crown hinge. Serious because prism is impacted and cracking is visible beyond the damaged area.

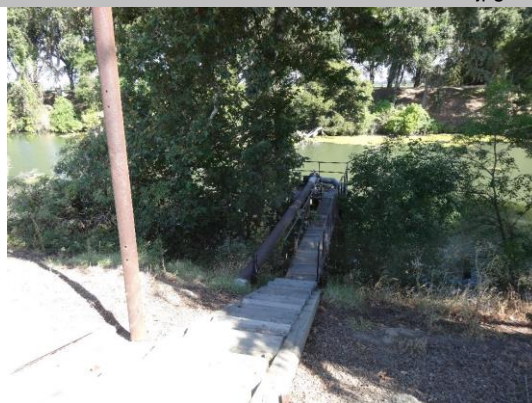
Photo 1 of 3 : UCIP_FA_2018_28265_51974.jpg

Comment Code						
Inspector Comment						
FS_ID:28265						
DS_ID:22448						
EP_NO: N/A						
Repair Type: Non-Urgent						
Crossing Status: Found						
UCIP Comments: - levee toe cut out at open end of the pipe.- service pole and control box on river bank.						
FIELD_STRUCT_DESC: 10-inch steel irrigation discharge pipe through the levee, invert elevation 7.8 feet below the crown. Pump and gate valve on a steel platform on the waterside (WS). (Plans for the installation of a vertical unit irrigation pumping plant and a 10-inch, 10-gauge steel discharge pipe through the levee authorized under Permit No. 1167, 1947 - Darrell Connor). [Additional Reference(s): DWR Levee Log, 2005. USACE Sacramento O&M Manual 112, March 1957, (HLM 5.80)].						
FS Date: 8/23/2013

WS view: walkway, pipe, pump and support deck on river bank.

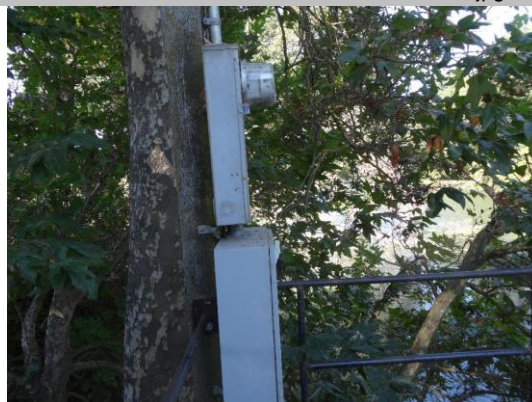
Photo 2 of 3 : UCIP_FA_2018_28265_51973.jpg

WS view: electric control box and power pole.

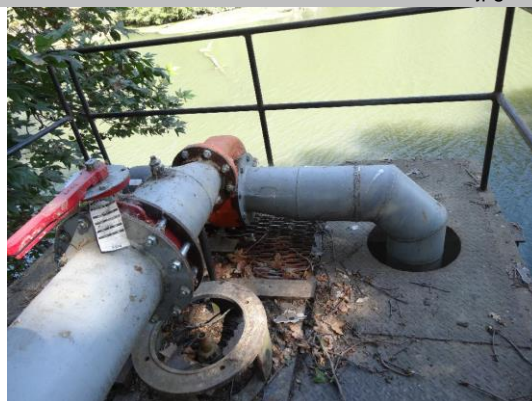
Photo 3 of 3 : UCIP_FA_2018_28265_51972.jpg

WS view: pipe, pump and gate valve on pump deck.

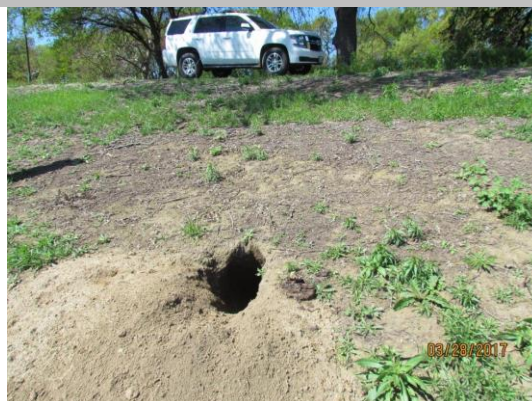
Photo 2 of 2 : FA_2018_RD0150_17_104_20180910_00099.jpg

LM Start	5.71	Rating **	U	Issue No.	104 (cont)
LM End	5.71	Issue Type +	Ma	Location *	LS
Category	Earthen Levee			GPS Latitude/Longitude	
				Start	End
Item	Animal Control			38.384026 °	38.384026 °
				-121.542455 °	-121.542455 °
DWR ID	DWR_RD0150_03_s_2017_104				
Comment Code					
A3 : No rodents visible, but rodent burrows visible; need to backfill and compact or grout burrows.					
Inspector Comment					
Animal hole appears to be inactive but should be backfilled.

View of a rodent hole on the landside toe of the levee. Spring 2017

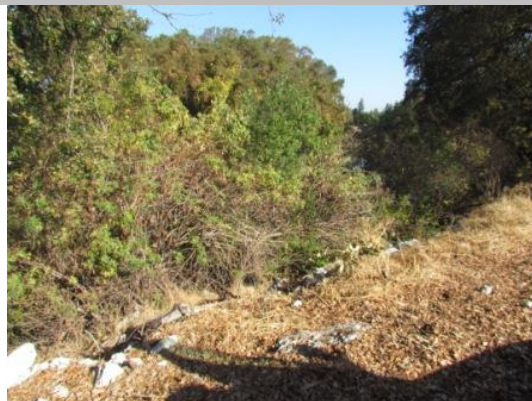
Photo 1 of 1 : FA_2018_RD0150_17_28_20180910_00010.jpg

LM Start	5.78	Rating **	M	Issue No.	28
LM End	5.78	Issue Type +	Ma	Location *	WS
Category	Earthen Levee			GPS Latitude/Longitude	
				Start	End
Item	Vegetation			38.384333 °	38.384333 °
				-121.541310 °	-121.541310 °
DWR ID	DWR_RD0150_03_s_2012_28				
Comment Code					
V2 : Remove the wild growth other than native grasses from the levee slopes.					
Inspector Comment

Wild growth was found on the waterside slope of the levee looking upstream.

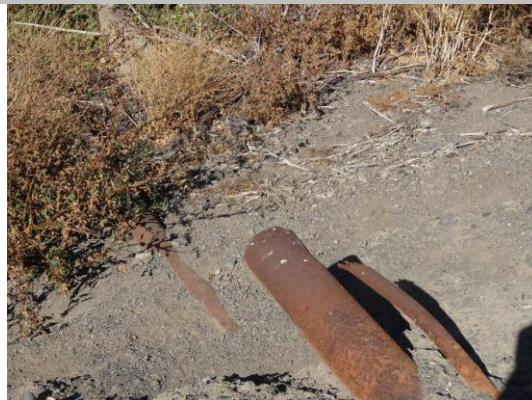
Photo 2 of 3 : UCIP_FA_2018_19403_32941.jpg

Comment Code						
Inspector Comment						
FS_ID:19403 DS_ID:22451 EP_NO: N/A Repair Type: Non-Urgent Crossing Status: Found UCIP Comments: - pipe ends open on both sides of the levee.- abandoned concrete box on WS.- two abandoned steel pipes (6" and 1") also found on WS. - needs proper abandonment FIELD_STRUCT_DESC: *ABANDONED* 6-inch steel irrigation discharge pipe through the levee, invert elevation 2.5 feet below the crown. Pump and gate valve removed prior to October 1962. Steel plate welded to the waterside (WS) end. Power pole and two anchors on the landside (LS) slope. (Warren Bogle). [Additional Reference(s): DWR Levee Log, 2005. USACE Sacramento O&M Manual 112, March 1957, (HLM 6.06)]. FS Date: 8/23/2013

WS view: Abandoned concrete box (top). Open ended 6" steel pipe, 1" steel pipe, and another 6" steel pipe on levee slope.

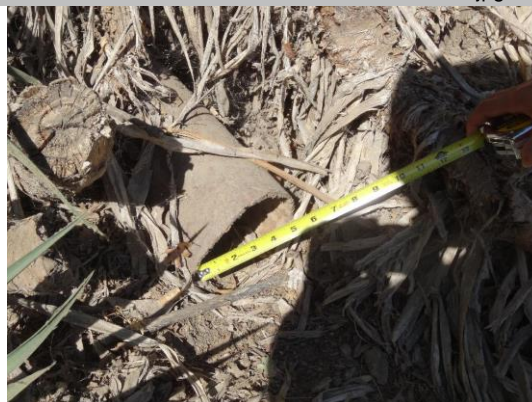
Photo 3 of 3 : UCIP_FA_2018_19403_32943.jpg

LS view: open end steel pipe on levee toe.

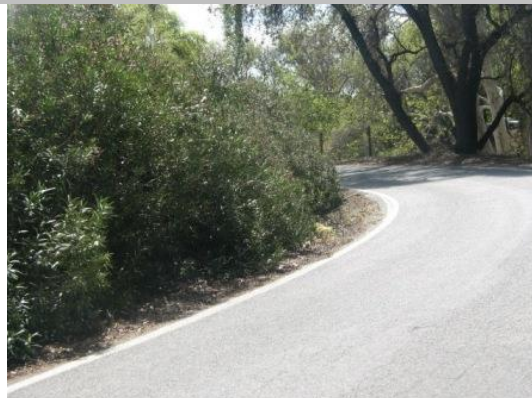
Photo 1 of 1 : FA_2018_RD0150_17_24_20180910_00007.jpg

LM Start	6.13	Rating **	U	Issue No.	24
LM End	6.20	Issue Type +	En	Location *	LS
Category	Earthen Levee			GPS Latitude/Longitude	
				Start	End
Item	Vegetation			38.388535 °	38.389391 °
				-121.541657 °	-121.541901 °
DWR ID	DWR_RD0150_03_s_2012_24				
Comment Code					
V6 : Landscaping					
Inspector Comment

Oleander on landward slope blocking view of levee.

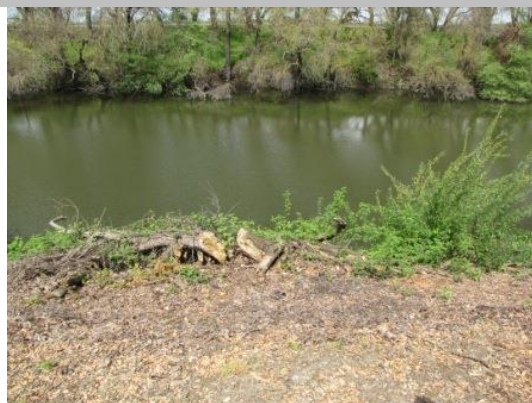
Photo 1 of 1 : FA_2018_RD0150_17_49_20180910_00038.jpg

LM Start	6.23	Rating **	N	Issue No.	49
LM End	6.23	Issue Type +	Ma	Location *	WS
Category	Earthen Levee			GPS Latitude/Longitude	
				Start	End
Item	Trim / Thin Trees			38.389658 °	38.389658 °
				-121.541518 °	-121.541518 °
DWR ID	DWR_RD0150_03_s_2012_49				
Comment Code					
T5 : Tree stumps.					
Inspector Comment

View of tree stumps on the waterward slope.

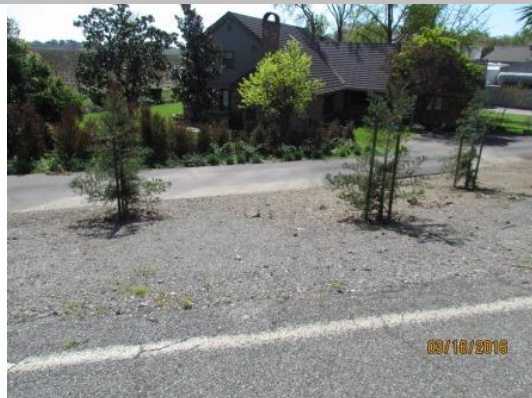
Photo 1 of 1 : FA_2018_RD0150_17_99_20180910_00097.jpg

LM Start	6.25	Rating **	M	Issue No.	99
LM End	6.25	Issue Type +	En	Location *	LS
Category	Earthen Levee			GPS Latitude/Longitude	
				Start	End
Item	Encroachments			38.389857 °	38.389857 °
				-121.541193 °	-121.541193 °
DWR ID	DWR_RD0150_03_s_2016_99				
Comment Code					
TR : Tree or limb					
Inspector Comment					
Landowner trees on the landside slope of the levee are unpermitted and need to be removed.

View of planted trees on the landside slope of the levee. Spring 2016

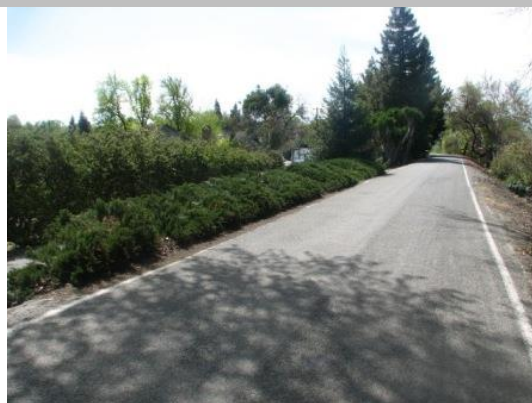
Photo 1 of 1 : FA_2018_RD0150_17_26_20180910_00008.jpg

LM Start	6.25	Rating **	U	Issue No.	26
LM End	6.29	Issue Type +	En	Location *	LS
Category	Earthen Levee			GPS Latitude/Longitude	
				Start	End
Item	Vegetation			38.389858 °	38.390115 °
				-121.541155 °	-121.540657 °
DWR ID	DWR_RD0150_03_s_2012_26				
Comment Code					
V6 : Landscaping					
Inspector Comment

Landscaping on landward slope.

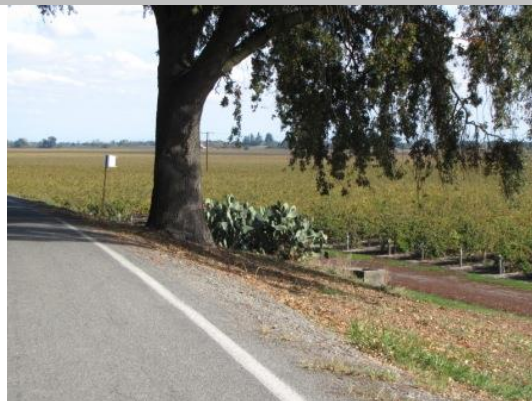
Photo 1 of 1 : FA_2018_RD0150_17_60_20180910_00051.jpg

LM Start	6.45	Rating **	M	Issue No.	60
LM End	6.45	Issue Type +	En	Location *	LS
Category	Earthen Levee			GPS Latitude/Longitude	
				Start	End
Item	Vegetation			38.391616 °	38.391616 °
				-121.538378 °	-121.538378 °
DWR ID	DWR_RD0150_03_s_2012_60				
Comment Code					
V6 : Landscaping					
Inspector Comment

View of landscaping along the landward slope.

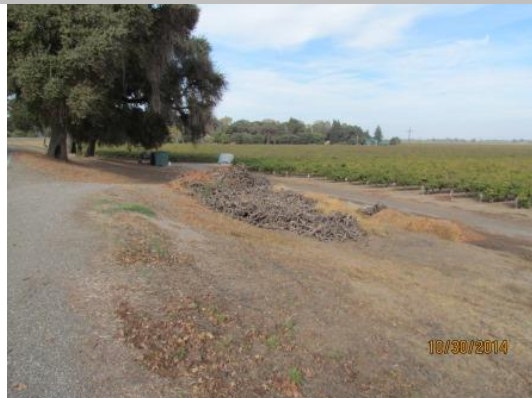
Photo 1 of 1 : FA_2018_RD0150_17_83_20180910_00078.jpg

LM Start	6.52	Rating **	M	Issue No.	83
LM End	6.52	Issue Type +	En	Location *	LS
Category	Earthen Levee			GPS Latitude/Longitude	
				Start	End
Item	Encroachments			38.392580 °	38.392580 °
				-121.538059 °	-121.538059 °
DWR ID	DWR_RD0150_03_f_2014_83				
Comment Code					
PR : Prunings					
Inspector Comment

Prunings were found on the landside toe of the levee looking upstream.
Fall 2014

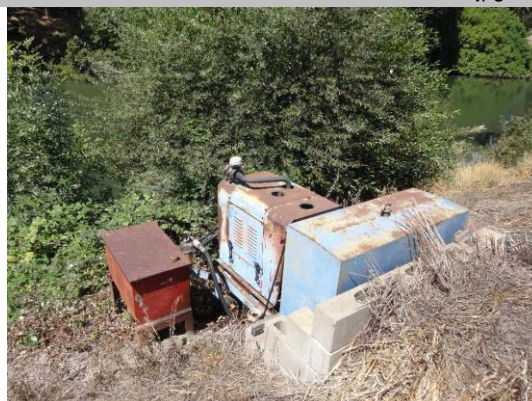
Photo 2 of 3 : UCIP_FA_2018_42692_35081.jpg

Comment Code						
Inspector Comment						
FS_ID:42692						
DS_ID:22457						
EP_NO: 14650						
Repair Type: Non-Urgent						
Crossing Status: Found						
UCIP Comments: Appears abandoned and if so should be done so properly.						
FIELD_STRUCT_DESC: 12-inch steel irrigation discharge pipe through the levee, 5 feet below the crown. Diesel powered slant pump on the waterside (WS). Concrete distribution box on the landside (LS) toe. (Plans to install a slant mounted pump on the WS of the levee with a 12-inch discharge pipe through the levee authorized under Permit No. 14650, 1987 - Webber Farms). [Additional Reference(s): DWR Levee Log, 2005].						
FS Date: 8/23/2013

WS view: diesel pump on steepest levee slope.

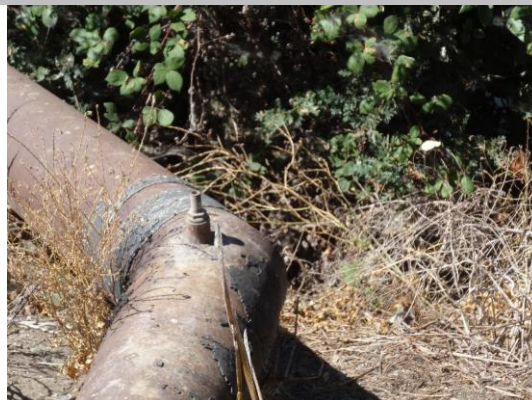
Photo 3 of 3 : UCIP_FA_2018_42692_35080.jpg

WS view: air vent on steel pipe.

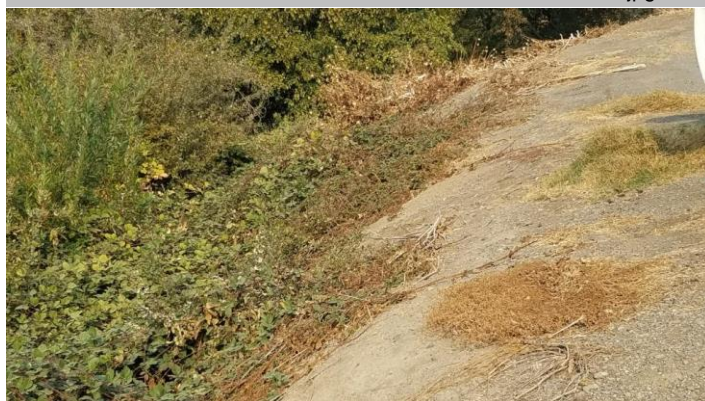
Photo 1 of 1 : FA_2018_RD0150_17_46_20181115_00198.jpg

LM Start	6.70	Rating **	U	Issue No.	46
LM End	6.70	Issue Type +	Ma	Location *	WS
Category	Earthen Levee			GPS Latitude/Longitude	
				Start	End
Item	Vegetation			38.395118 °	38.395118 °
				-121.538613 °	-121.538613 °
DWR ID	DWR_RD0150_03_f_2018_46				
Comment Code					
V2 : Remove the wild growth other than native grasses from the levee slopes.					
Inspector Comment					
Remove wild growth down to 20 ft. from levee shoulder.

View of wild growth within levee easement. Fall 2018

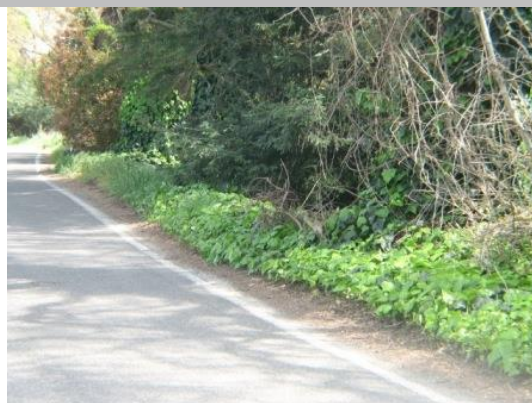
Photo 1 of 1 : FA_2018_RD0150_17_30_20180910_00011.jpg

LM Start	6.78	Rating **	U	Issue No.	30
LM End	6.80	Issue Type +	En	Location *	LS
Category	Earthen Levee			GPS Latitude/Longitude	
				Start	End
Item	Vegetation			38.395791°	38.395869°
				-121.537399°	-121.537101°
DWR ID	DWR_RD0150_03_s_2012_30				
Comment Code					
V6 : Landscaping					
Inspector Comment

Landscaping on landward slope blocking view

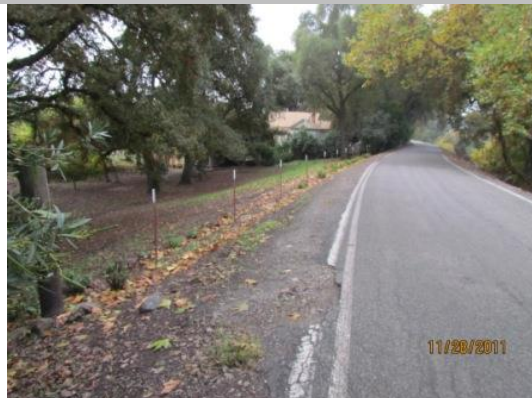
Photo 1 of 1 : FA_2018_RD0150_17_13_20180910_00004.jpg

LM Start	6.82	Rating **	M	Issue No.	13
LM End	6.93	Issue Type +	En	Location *	LS
Category	Earthen Levee			GPS Latitude/Longitude	
				Start	End
Item	Encroachments			38.395998 °	38.395470 °
				-121.536613 °	°
DWR ID	DWR_RD0150_03_s_2012_13				
Comment Code					
FE : Fence					
Inspector Comment

Fence was found on the landside of the levee looking downstream. Fall 2011

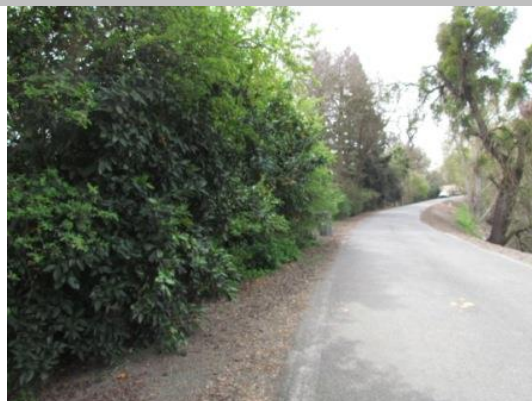
Photo 1 of 1 : FA_2018_RD0150_17_933_20180910_00135.jpg

LM Start	6.85	Rating **	U	Issue No.	933
LM End	6.93	Issue Type +	En	Location *	LS
Category	Earthen Levee			GPS Latitude/Longitude	
				Start	End
Item	Vegetation			38.396187 °	38.396989 °
				-121.536180 °	-121.535151 °
DWR ID	DWR_RD0150_03_s_2012_933				
Comment Code					
V6 : Landscaping					
Inspector Comment					
Landscaping needs to be maintained.

View of the landscape on the landside shoulder of the levee looking downstream.

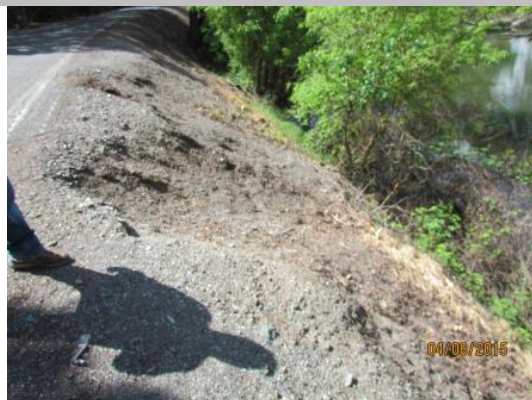
Photo 1 of 2 : FA_2018_RD0150_17_61_20180910_00052.jpg

LM Start	6.90	Rating **	M	Issue No.	61							
LM End	6.90	Issue Type +	Ob	Location *	WS							
Category	Earthen Levee		GPS Latitude/Longitude									
			Start	End								
Item	Erosion / Bank Caving		38.396655 °	38.396655 °								
			-121.535485 °	-121.535485 °								
DWR ID	DWR_RD0150_03_s_2012_61											
Comment Code												
E1 : Note and monitor erosion site.												
Inspector Comment

View of erosion on the waterside of the levee during spring 2015 inspection.

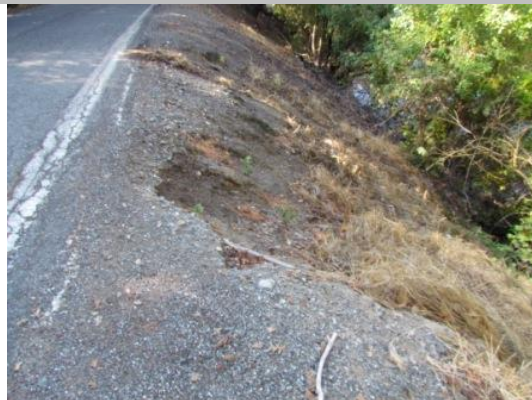
Photo 2 of 2 : FA_2018_RD0150_17_61_20180910_00053.jpg

LM Start	6.90	Rating **	M	Issue No.	61 (cont)	
LM End	6.90	Issue Type +	Ob	Location *	WS	
Category	Earthen Levee			GPS Latitude/Longitude		
				Start		End
Item	Erosion / Bank Caving			38.396655 °		38.396655 °
				-121.535485 °		-121.535485 °
DWR ID	DWR_RD0150_03_s_2012_61					
Comment Code						
E1 : Note and monitor erosion site.						
Inspector Comment

Erosion was found on the waterside slope of the levee looking downstream. This updated picture was taken during fall 2012 inspection.

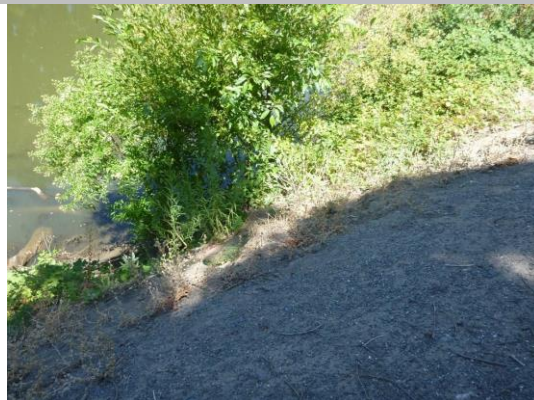
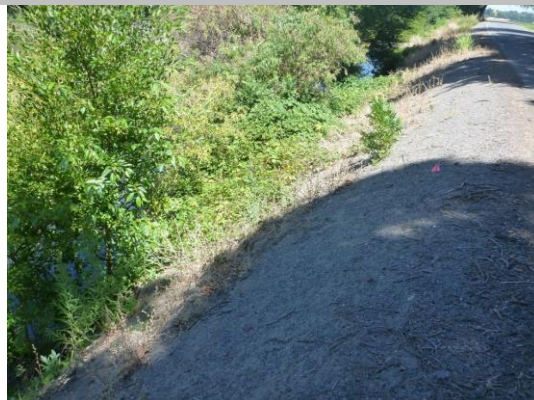
Description: Erosion was observed on the waterside levee slope on the east (left) bank of Elk Slough. The site is approximately 10 feet long and progresses up to the levee crown. See attached pages for photos.
Site ID No: 314

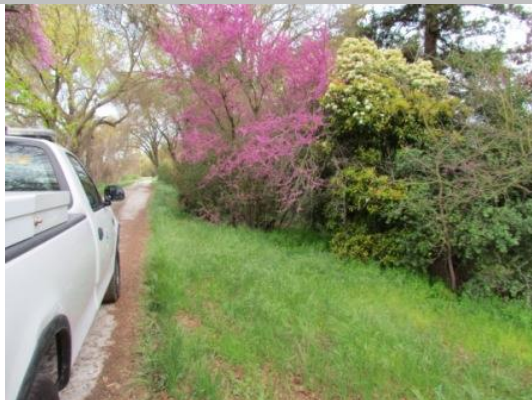
Photo 1 of 2 : FA_2018_RD0150_17_32_20180910_00013.jpg

LM Start	7.29	Rating **	U	Issue No.	32
LM End	7.34	Issue Type +	En	Location *	LS
Category	Earthen Levee			GPS Latitude/Longitude	
				Start	End
Item	Vegetation			38.401738 °	38.402296 °
				-121.537127 °	-121.537678 °
DWR ID	DWR_RD0150_03_s_2012_32				
Comment Code					
V6 : Landscaping					
Inspector Comment

Vegetation on the landside of the levee looking upstream. This picture was taken during spring 2012 inspection.

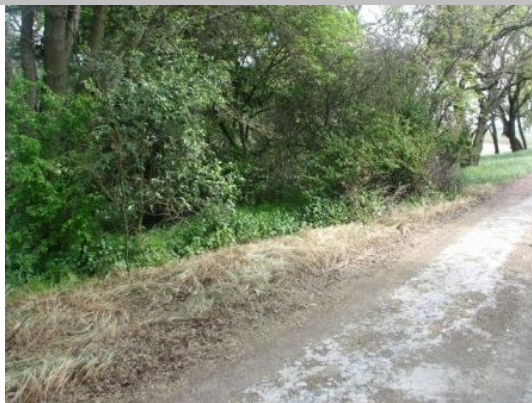
Photo 2 of 2 : FA_2018_RD0150_17_32_20180910_00014.jpg

Landscaping on landward slope blocking view

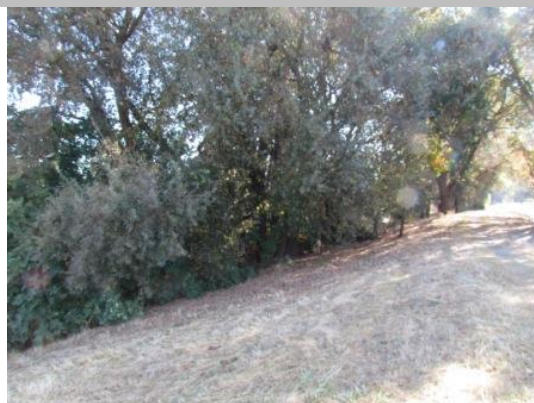
Photo 1 of 1 : FA_2018_RD0150_17_934_20180910_00136.jpg

LM Start	7.44	Rating **	U	Issue No.	934
LM End	7.44	Issue Type +	En	Location *	LS
Category	Earthen Levee			GPS Latitude/Longitude	
				Start	End
Item	Vegetation			38.403566 °	38.403566 °
				-121.538886 °	-121.538886 °
DWR ID	DWR_RD0150_03_s_2012_934				
Comment Code					
V6 : Landscaping					
Inspector Comment

Landscaping was blocking the visibility on the landside of the levee looking downstream.

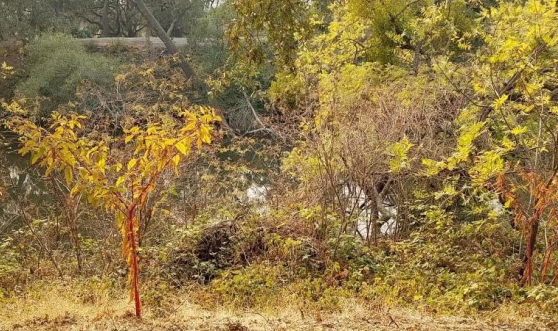
Photo 1 of 2 : FA_2018_RD0150_17_52_20181115_00201.jpg

View of the tree trunk on the waterside toe of the levee. Fall 2018

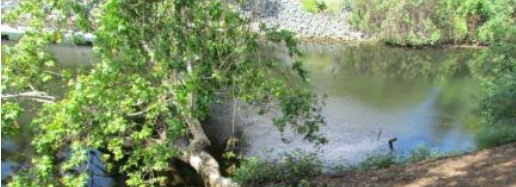
Photo 1 of 1 : FA_2018_RD0150_17_396_20180910_00134.jpg

Slope instability was found on the waterside toe of the levee looking

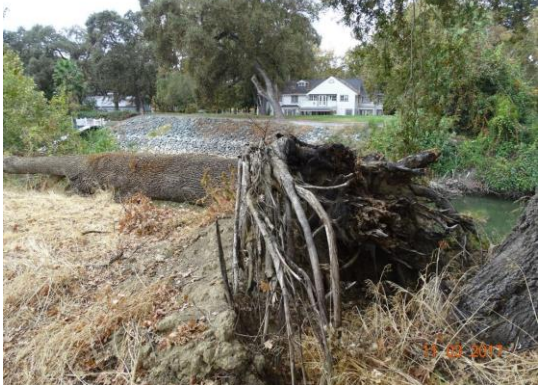
Photo 1 of 1 : FA_2018_RD0150_17_129_20180910_00133.jpg

View of a tree stump on the waterside shoulder of the levee. Fall 2017

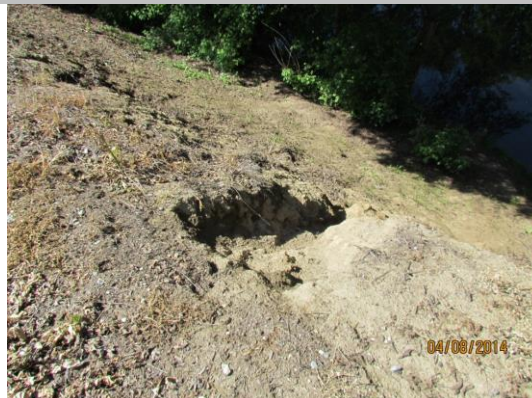
Photo 2 of 2 : FA_2018_RD0150_17_92_20180910_00089.jpg

LM Start	8.02	Rating **	M	Issue No.	92 (cont)	
LM End	8.02	Issue Type +	Ma	Location *	WS	
Category	Earthen Levee			GPS Latitude/Longitude		
				Start		End
Item	Slope Stability			38.409130 °		38.409130 °
				-121.539971 °		-121.539971 °
DWR ID	DWR_RD0150_03_s_2014_92					
Comment Code						
S1 : Repair slope instability.						
Inspector Comment

Slope instability was found on the waterside of the levee looking downstream.

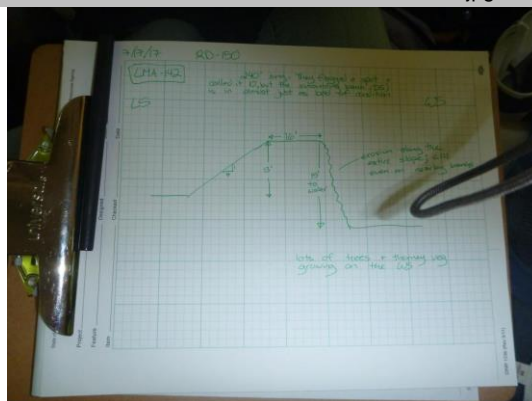
Photo 4 of 4 : LEVAL_FA_2018_315_2187.jpg

Comment Code					
Inspector Comment					
Levee Evaluation Comments					
Description:Erosion was observed on the waterside levee slope on the east (left) bank of Elk Slough. The site is approximately 10 feet long and progresses up to the levee crown. See attached pages for photos.					
Site ID No:315					
Site Designation:LMA-142					
Repair Type: Erosion					
Rating:Serious					
Field Date:7/17/2017					
Notes: The erosion extends along most of the slope. Nearby WS banks are all very steep (1:1 or less). Serious because the erosion extend along the entire slope, but not into the crown. Fall 2018 DWR Inspector: Erosion not visible during this inspection but is marked.

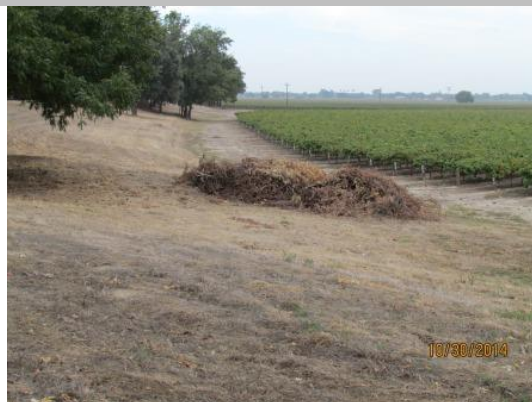
Photo 1 of 1 : FA_2018_RD0150_17_82_20180910_00077.jpg

LM Start	8.05	Rating **	M	Issue No.	82
LM End	8.05	Issue Type +	En	Location *	LS
Category	Earthen Levee			GPS Latitude/Longitude	
				Start	End
Item	Encroachments			38.409224 °	38.409224 °
				-121.539350 °	-121.539350 °
DWR ID	DWR_RD0150_03_f_2013_82				
Comment Code					
PR : Prunings					
Inspector Comment

Prunings were found on the landside toe of the levee looking upstream.
Fall 2014

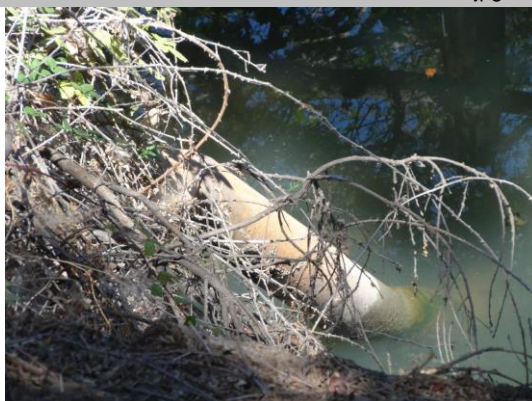
Photo 1 of 3 : UCIP_FA_2018_53335_33627.jpg

Comment Code						
Inspector Comment						
FS_ID:53335 DS_ID:22466 EP_NO: N/A Repair Type: Urgent Crossing Status: Found UCIP Comments: 06/05/2018: Same as last inspection so the crossing remains Urgent due to caved in levee below pipe at gate valve; needs proper abandonment (DWR UCIP - D. Sanoski).07/08/2016: Needs proper abandonment. Levee caved in below pipe at gate valve on WS. Discussed abandonment with Warren Bogle of Colby Ranch. (K. Fazel - UCIP)08/23/2013: Needs proper abandonment (P. Amatya - DWR) FIELD_STRUCT_DESC: *ABANDONED* 10-inch steel irrigation discharge pipe through the levee, invert elevation 13.8 feet below the crown. Gate valve on the waterside (WS) slope. Pilings in the stream, but no pump was found. Service pole with guy wire on the landside (LS) slope. Standpipe on the LS slope. (A. Colby). [Additional Reference(s): DWR Levee Log, 2005. USACE Sacramento O&M Manual 112, March 1957, (HLM 8.34)]. FS Date: 6/5/2018 3:30:00 PM

WS view: pipe visible on levee slope and in the stream.

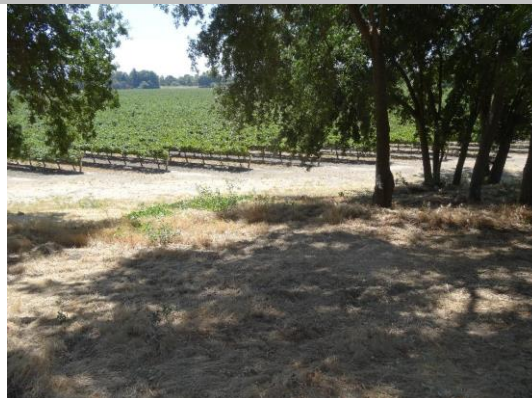
Photo 3 of 3 : UCIP_FA_2018_53335_33625.jpg

Item	DWR UCIP Field Study		38.408619 °	38.408619 °								
			-121.536768 °	-121.536768 °								
DWR ID	22466											
Comment Code												
Inspector Comment												
FS_ID:53335 DS_ID:22466 EP_NO: N/A Repair Type: Urgent Crossing Status: Found UCIP Comments: 06/05/2018: Same as last inspection so the crossing remains Urgent due to caved in levee below pipe at gate valve; needs proper abandonment (DWR UCIP - D. Sanoski).07/08/2016: Needs proper abandonment. Levee caved in below pipe at gate valve on WS. Discussed abandonment with Warren Bogle of Colby Ranch. (K. Fazel - UCIP)08/23/2013: Needs proper abandonment (P. Amatya - DWR) FIELD_STRUCT_DESC: *ABANDONED* 10-inch steel irrigation discharge pipe through the levee, invert elevation 13.8 feet below the crown. Gate valve on the waterside (WS) slope. Pilings in the stream, but no pump was found. Service pole with guy wire on the landside (LS) slope. Standpipe on the LS slope. (A. Colby). [Additional Reference(s): DWR Levee Log, 2005. USACE Sacramento O&M Manual 112, March 1957, (HLM 8.34)]. FS Date: 6/5/2018 3:30:00 PM

LS view: no pipe and structure found on landside.

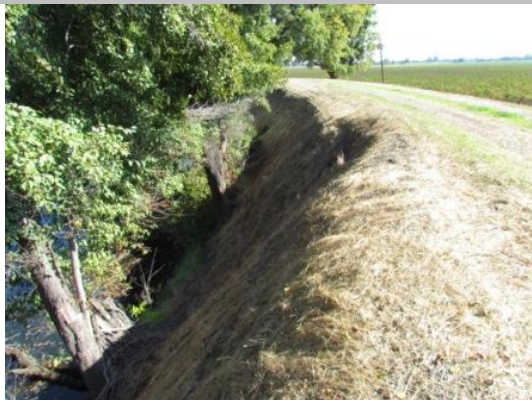
Photo 2 of 2 : FA_2018_RD0150_17_67_20180910_00059.jpg

LM Start	8.33	Rating **	M	Issue No.	67 (cont)	
LM End	8.33	Issue Type +	Ma	Location *	WS	
Category	Earthen Levee			GPS Latitude/Longitude		
				Start		End
Item	Erosion / Bank Caving			38.407958 °	38.407958 °	
				-121.534583 °	-121.534583 °	
DWR ID	DWR_RD0150_03_s_2012_67					
Comment Code						
E1 : Note and monitor erosion site.						
Inspector Comment

Erosion was found on the waterside shoulder of the levee looking upstream. This picture was taken during fall 2012 inspection.

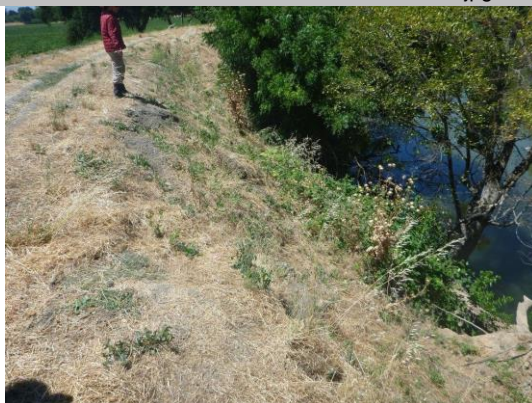
Photo 1 of 3 : LEVAL_FA_2018_316_2180.jpg

LM Start	8.35	Rating **	A/W	Issue No.	123
LM End	8.35	Issue Type +	Ma	Location *	
Category	Supplemental			GPS Latitude/Longitude	
				Start	End
Item	2017 Storm Damage			38.407983 °	38.407992 °
				-121.534322 °	-121.534289 °
DWR ID	DWR_RD0150_03_f_2017_123				
Comment Code					
Inspector Comment					
Levee Evaluation Comments					
Description:Erosion was observed on the waterside levee slope on the east (left) bank of Elk Slough. The site is approximately 10 feet long. See attached pages for photos.					
Site ID No:316					
Site Designation:LMA-143					
Repair Type: Erosion					
Rating:Serious					
Field Date:7/17/2017					
Notes: 3 large trees in/ajacent to site including a fallen tree in the middle of the erosion. Erosion on almost the whole slope, but doesn?t cut into the crown. Serious because erosion cuts into levee significantly here.

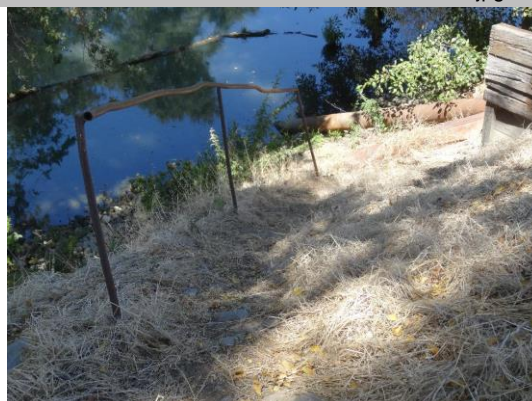
Photo 1 of 3 : UCIP_FA_2018_41648_33642.jpg

Comment Code						
Inspector Comment						
FS_ID:41648 DS_ID:22467 EP_NO: N/A Repair Type: Non-Urgent Crossing Status: Found UCIP Comments: - walkway in poor functional condition- an abandoned 8-inch steel pipe next to 12" pipe. This 8" pipe might have merged with 12" pipe under the levee .- Pipe and pump inside concrete masonry wall. FIELD_STRUCT_DESC: 12-inch steel irrigation discharge pipe through the levee, invert elevation 13 feet below the crown. Pump and gate valve in a pump house on the waterside (WS) slope. Concrete distribution box at the landside (LS) toe. Service pole on the WS shoulder. [Additional Reference(s): DWR Levee Log, 2005. USACE Sacramento O&M Manual 112, March 1957, (HLM 8.51)]. FS Date: 8/23/2013

WS view: walkway and inlet pipe on levee slope.

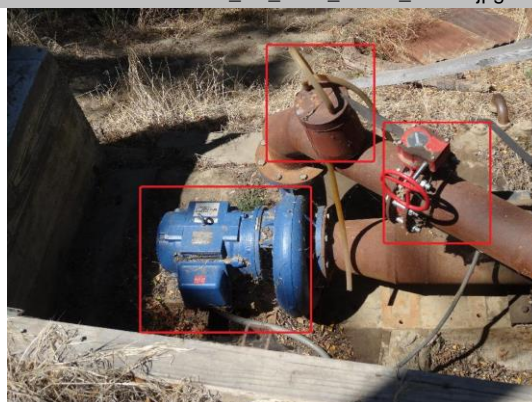
Photo 2 of 3 : UCIP_FA_2018_41648_33641.jpg

WS view: pump, gate valve, and airvent on pipe inside concrete masonry box.

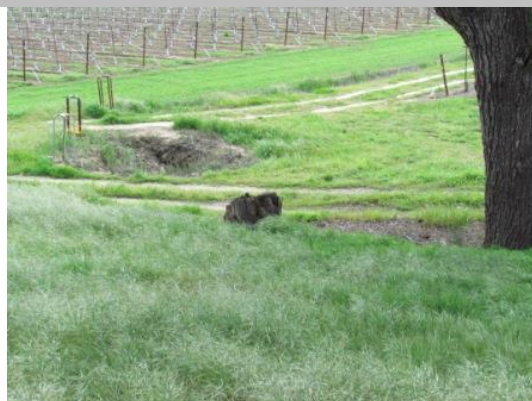
Photo 1 of 1 : FA_2018_RD0150_17_90_20180910_00084.jpg

LM Start	8.46	Rating **	N	Issue No.	90
LM End	8.46	Issue Type +	Ma	Location *	LS
Category	Earthen Levee			GPS Latitude/Longitude	
				Start	End
Item	Trim / Thin Trees			38.409220°	38.409220°
				-121.532801°	-121.532801°
DWR ID	DWR_RD0150_03_s_2012_90				
Comment Code					
T5 : Tree stumps.					
Inspector Comment

A tree stump was found on the landside of the levee looking upstream.

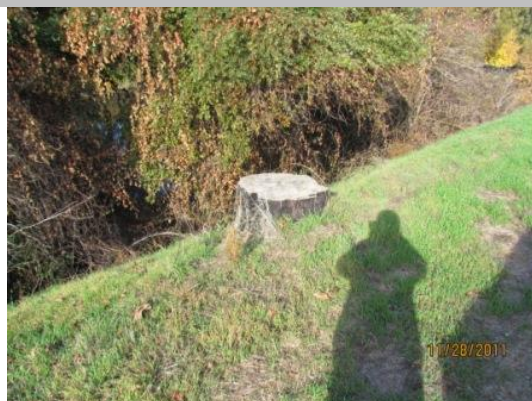
Photo 1 of 1 : FA_2018_RD0150_17_55_20180910_00046.jpg

LM Start	8.50	Rating **	N	Issue No.	55
LM End	8.50	Issue Type +	Ma	Location *	WS
Category	Earthen Levee			GPS Latitude/Longitude	
				Start	End
Item	Trim / Thin Trees			38.409559 °	38.409559 °
				-121.532356 °	-121.532356 °
DWR ID	DWR_RD0150_03_s_2012_55				
Comment Code					
T5 : Tree stumps.					
Inspector Comment

A tree stump was found on the waterside of the levee looking upstream.
Fall 2011

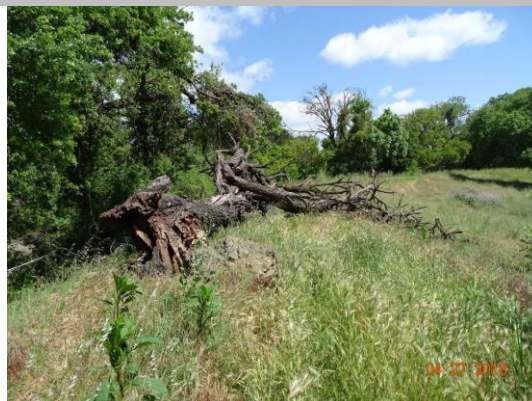
Photo 1 of 1 : FA_2018_RD0150_17_128_20180910_00132.jpg

LM Start	8.95	Rating **	M	Issue No.	128
LM End	8.95	Issue Type +	Ma	Location *	CR
Category	Earthen Levee			GPS Latitude/Longitude	
				Start	End
Item	Encroachments			38.414831 °	38.414831 °
				-121.528982 °	-121.528982 °
DWR ID	DWR_RD0150_03_s_2018_128				
Comment Code					
TR : Tree or limb					
Inspector Comment					
Remainder of downed tree remains on levee crown and shoulder.

Downed tree blocking crown looking north. Spring 2018

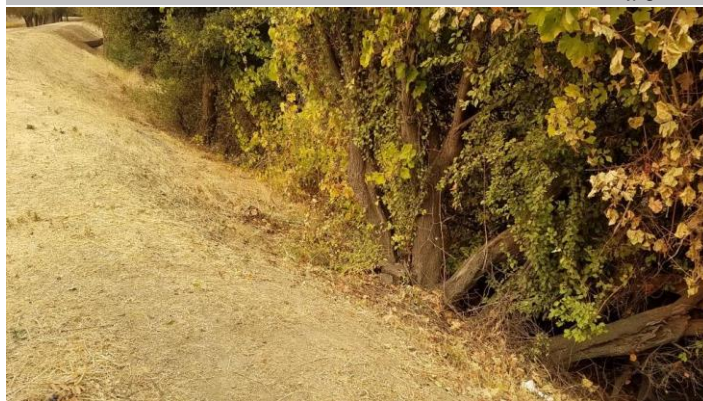
Photo 1 of 1 : FA_2018_RD0150_17_97_20181115_00206.jpg

LM Start	9.20	Rating **	U	Issue No.	97
LM End	9.20	Issue Type +	Ma	Location *	WS
Category	Earthen Levee			GPS Latitude/Longitude	
				Start	End
Item	Vegetation			38.413388 °	38.413388 °
				-121.526130 °	-121.526130 °
DWR ID	DWR_RD0150_03_f_2018_97				
Comment Code					
V2 : Remove the wild growth other than native grasses from the levee slopes.					
Inspector Comment					
Grapevines block visibility and need to be cleared.

View of dense vegetation that blocks visibility of levee slope. Fall 2018

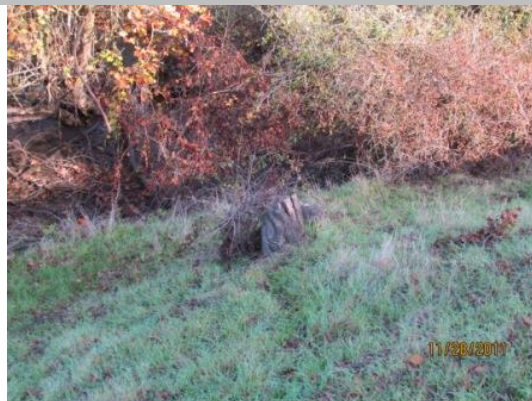
Photo 1 of 1 : FA_2018_RD0150_17_59_20180910_00050.jpg

LM Start	9.21	Rating **	N	Issue No.	59
LM End	9.21	Issue Type +	Ma	Location *	WS
Category	Earthen Levee			GPS Latitude/Longitude	
				Start	End
Item	Trim / Thin Trees			38.413268 °	38.413268 °
				-121.525929 °	-121.525929 °
DWR ID	DWR_RD0150_03_s_2012_59				
Comment Code					
T5 : Tree stumps.					
Inspector Comment

A tree stump was found on the waterside of the levee looking upstream. Fall 2011

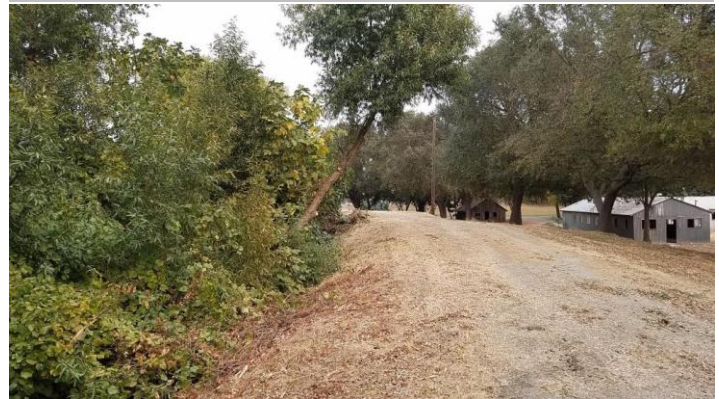
LM Start	9.31	Rating **	U	Issue No.	73 (cont)
LM End	9.35	Issue Type +	Ma	Location *	WS

View of dense vegetation within levee easement. Fall 2018

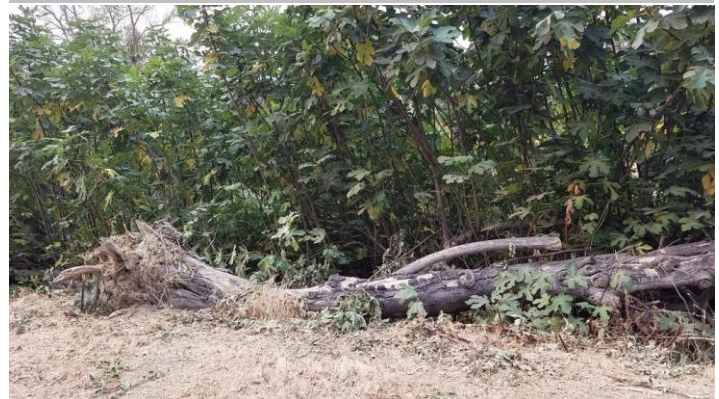
View of fallen tree on levee slope. Fall 2018

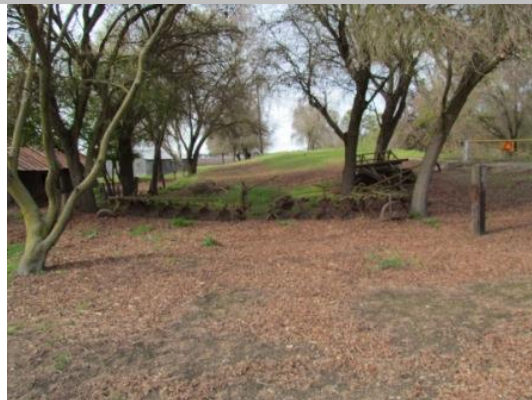
Photo 1 of 1 : FA_2018_RD0150_17_950_20180910_00140.jpg

LM Start	9.39	Rating **	M	Issue No.	950
LM End	9.39	Issue Type +	En	Location *	LS
Category	Earthen Levee			GPS Latitude/Longitude	
				Start	End
Item	Encroachments			38.413560 °	38.413560 °
				-121.522936 °	-121.522936 °
DWR ID	DWR_RD0150_03_s _ 2012_950				
Comment Code					
EQ : Equipment					
Inspector Comment

Equipment was found on the landside of the levee looking downstream.
